# **Vulnerability of Electric Power Systems to Volcanic Ashfall Hazards**

**Doctor of Philosophy in Hazard and Disaster  
Management**

**John Blackburn Wardman**

**2013**

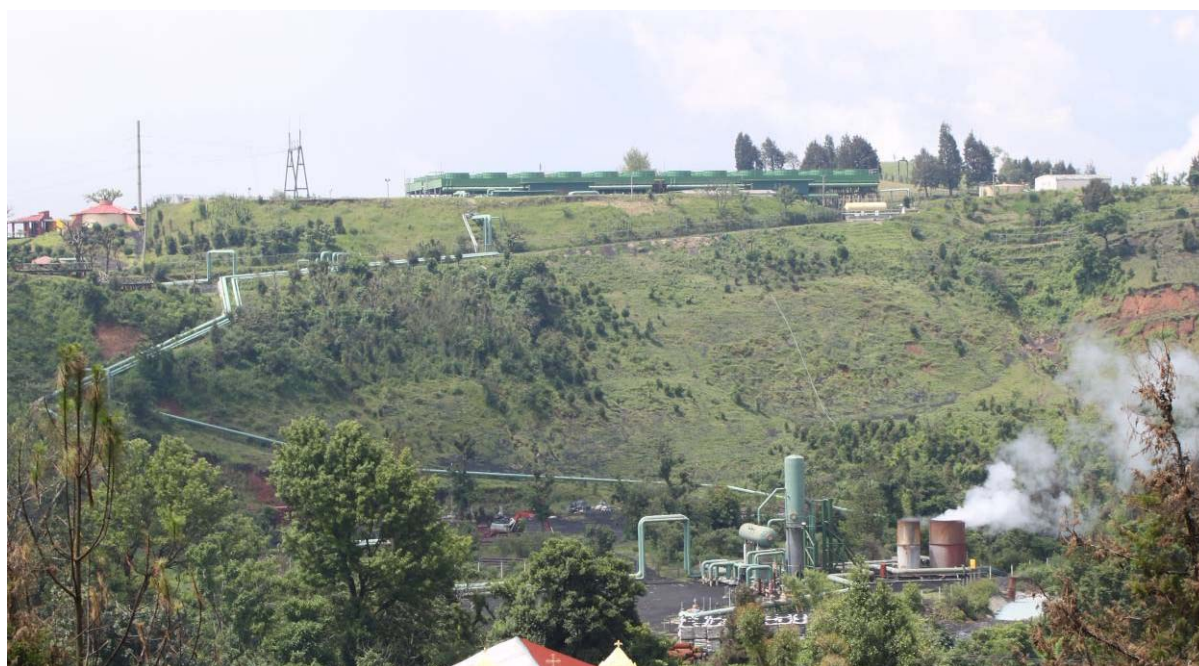
During the 27 May 2010 eruption, the San Francisco de Sales area received an estimated 20 cm of tephra, ranging from coarse (e.g. >1.5 mm) to lapilli-sized. Ballistic bombs and blocks (up to 25 cm diameter long axis) also fell in this area, and extensive damage was caused locally. At the Amatitlán plant, the worst damage was to steam condenser fans and roofs. As the fans were uncovered, fan blades suffered abrasion damage from tephra fall as well as denting and bending from falling blocks which rendered the damaged units nonoperational (Amatitlán plant operator). Three fan blades needed to be replaced. Cleaning of fans was slow (days to weeks), as it required the use of vacuum cleaners to remove particles from the intricate arrangement of fan blades, cooling fins and condenser coils. Operations were discontinued immediately after the eruption and the plant remained offline for three weeks while cleaning and repairs were carried out.

**Figure 3.1** Amatitlán geothermal plant.

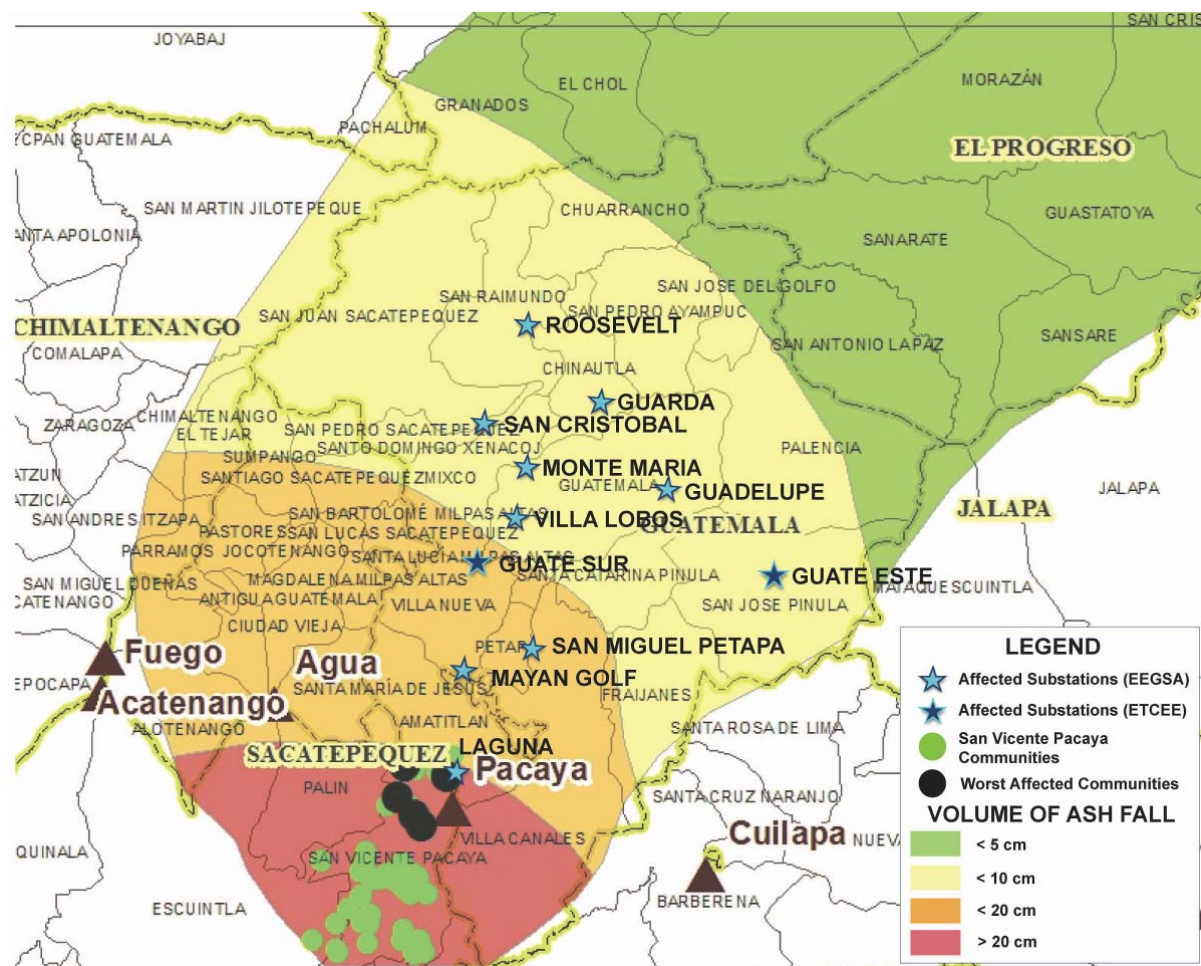
ETCEE manages two large (230 kV) substations which were affected by the eruption. These stations (Guate Sur and Guate Este) required offline cleaning shortly before the arrival of the tropical storm (Figure 3.5). One of four transformer banks was de-energised at a time and each bank remained offline for a period of two hours. Cleaning involved the sweeping and brushing of tephra from substation hardware and surrounding yards. This tephra was shovelled and trucked away to a nearby area to serve as landfill. Substation gear was subsequently washed using high-pressure water pumps.

**Figure 3.5** Isopach map of 27 May 2010 eruption showing approximate location of affected substations. Blue stars represent substations and their names are juxtaposed (adapted from INSIVUMEH map).

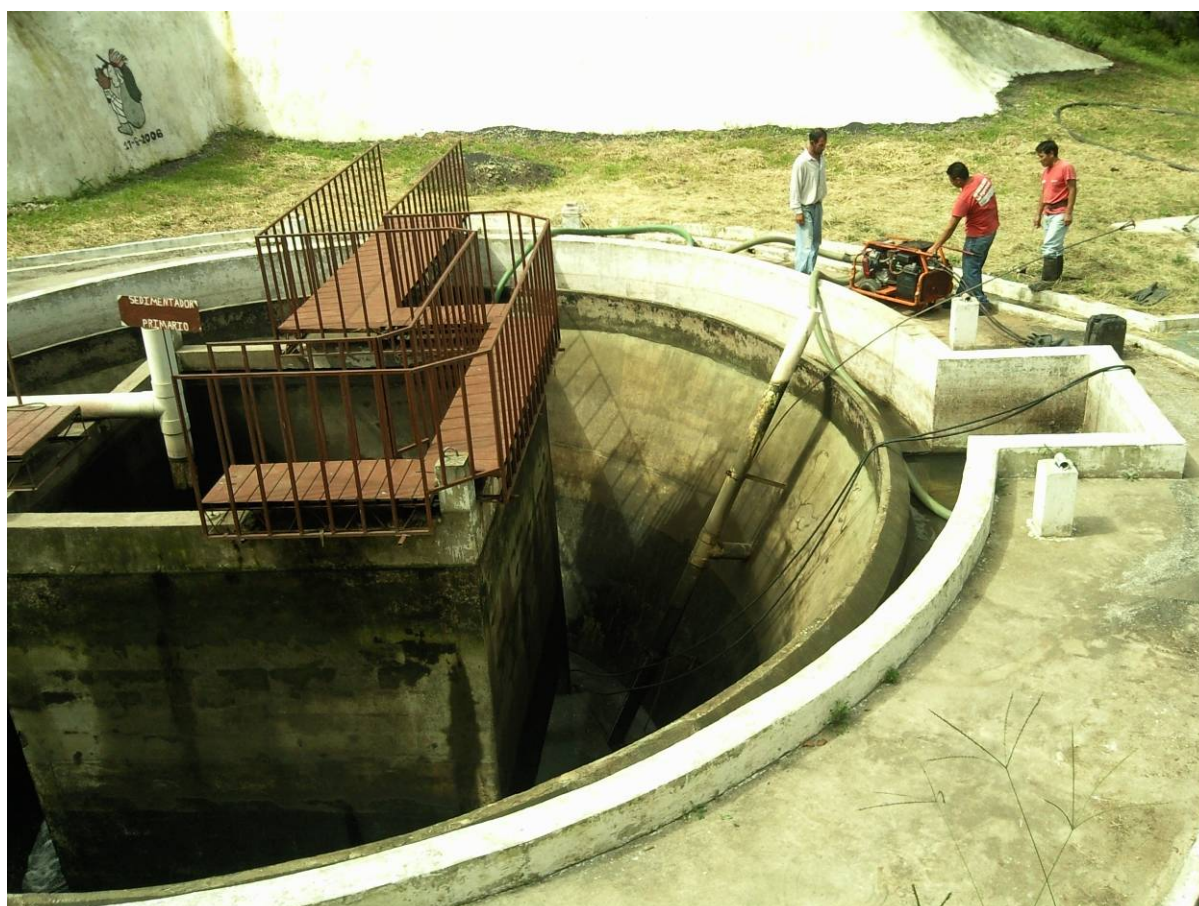
**Figure 3.6** Cleaning out Imhoff tank at University of San Carlos, Guatemala City (photo: Mapreco).

Tephra entered wastewater treatment systems both via sewer lines and by direct deposition into ponds. Mapreco staff described the impact on one particular system (the system at the University of San Carlos, shown in Figure 3.6) in some detail. Approximately 4-5 metres of tephra accumulated in the Imhoff tank. The removal process consisted of mixing the tephra with the sludge so that the heavy tephra sank to the bottom. Then sludge pumps (15 cm internal diameter piping) were used to remove the lighter material on top, and the rest was dug out manually. There was heavy wear and tear on this equipment due to abrasion damage to propellers (Figure 3.7). Their normal lifetime of two years was reduced to 15 days. It was generally difficult cleaning out tephra-contaminated sludge as the tephra was reportedly very dense and 'hard to shift' with a hose. The same approach (using a suction pump to remove the lighter material then shovelling out the denser material) was used for many different types of treatment plants, such as small aerobic plants used to service condominiums (Figure 3.8).

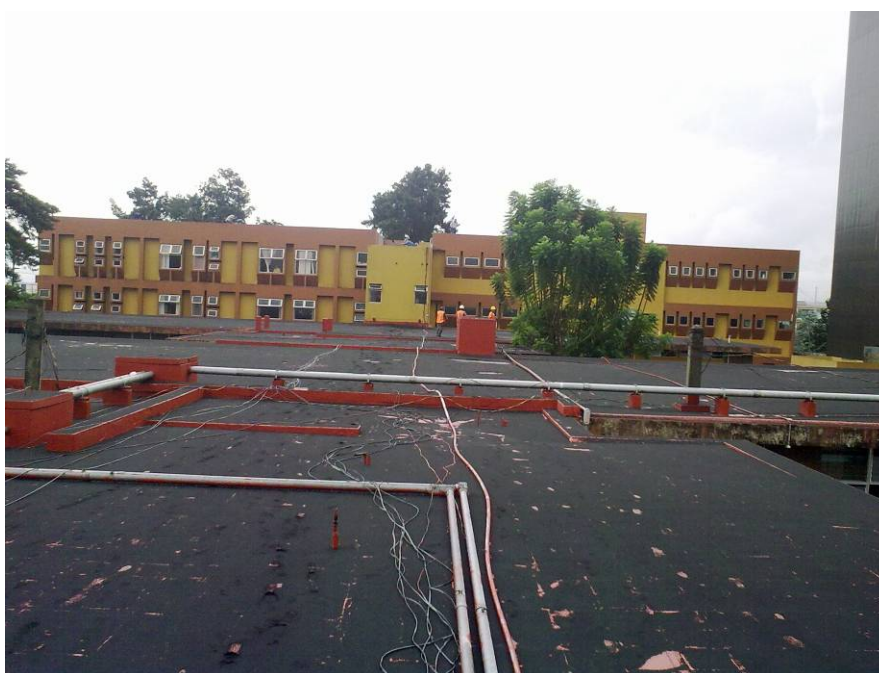
The extensive roofs of hospital B (an estimated 10,000 m<sup>2</sup>, hospital maintenance staff) were covered in 2-3 cm coarse tephra. These roofs are largely flat, and thus tephra was not washed off. The rainfall received mostly served to dampen the tephra. The quantity of wet tephra involved meant that the cleanup was too major for the normal cleaning team. On the following day, all available staff were assigned to help with the cleanup and a further 25 Army personnel were also brought in to help (hospital maintenance staff). Internal cleaning was also suspended to focus on the external cleanup; as a result two additional cleaners were hired for a month afterwards to assist with internal cleaning.

**Figure 3.10** Roof of hospital B covered in tephra.

Cleanup efforts were directed towards the roofs, to prevent further rains from washing it into drainpipes and blocking them. It took three to four days to clear tephra from the roof. Maintenance staff kindly provided us with photos of the cleanup (Figures 3.10 and 3.11).

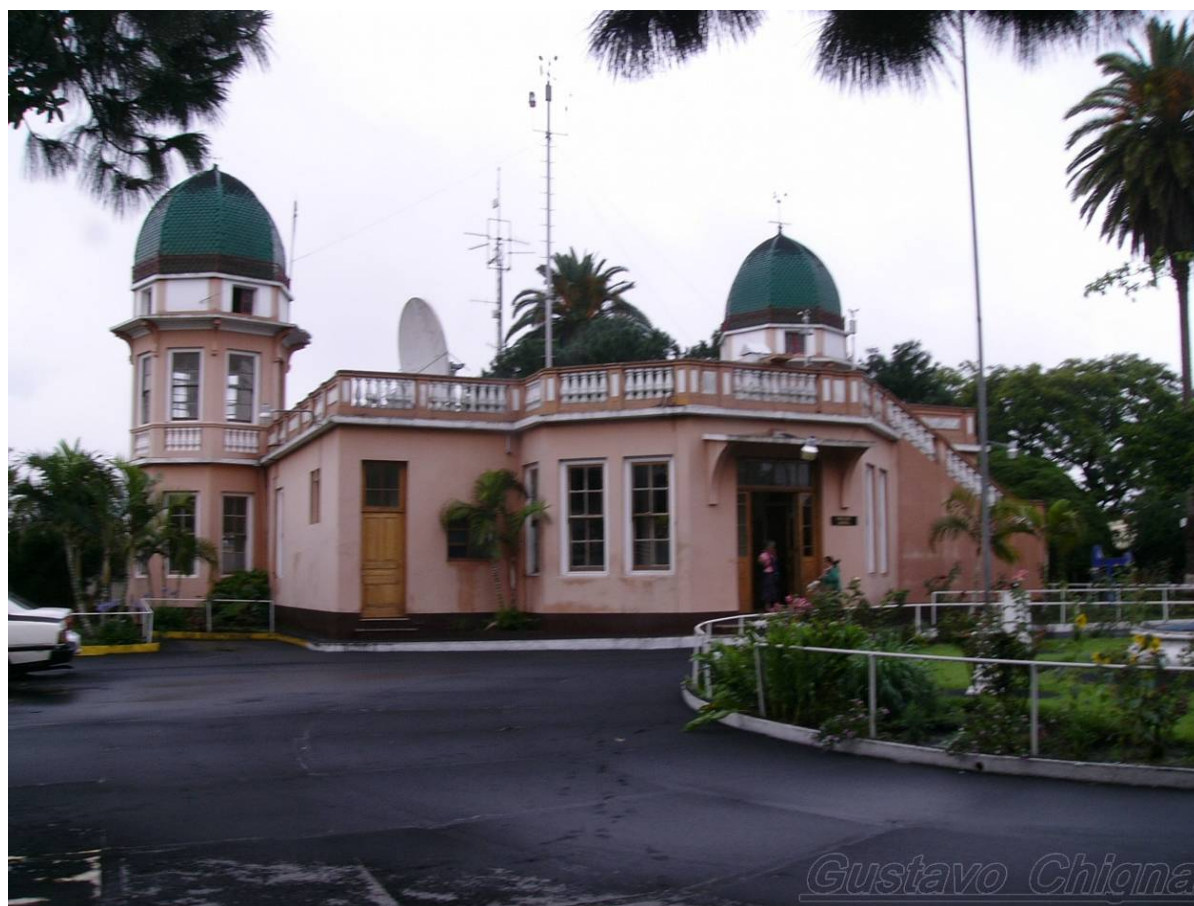
**Figure 3.12** Coarse, sand-sized basaltic tephra covering a paved area in Guatemala City. (photo: Gustavo Chigna, INSIVUMEH).

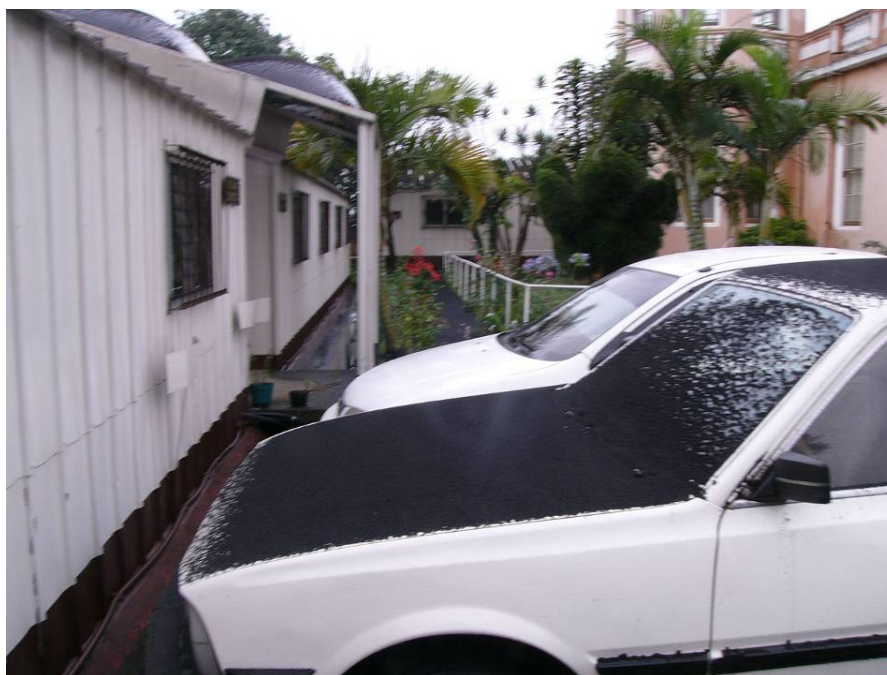
**Figure 3.13** Coarse, sand-sized basaltic tephra covering vehicle (photo: Gustavo Chigna, INSIVUMEH).

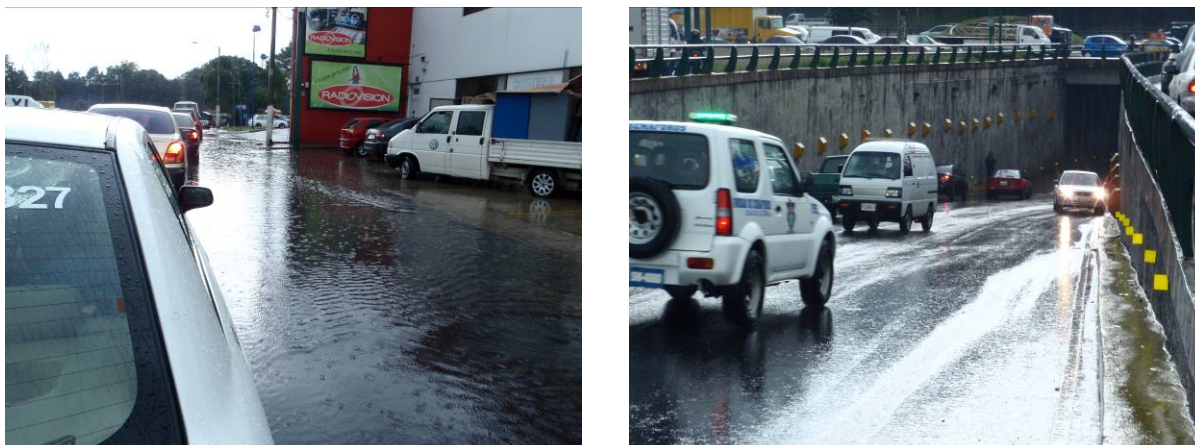
While the heavy rains that followed the tephra fall did wash the tephra from the streets, tephra then blocked drains all over the city, and widespread surface flooding occurred (Figure 3.15). The tropical storm, described briefly in Section 2.4, caused serious flooding on a wide scale across Guatemala. The civil defence impacts caused by this storm can be seen as Appendix 3 to this report. In Guatemala City, surface flooding was widespread, with underpasses being particularly affected.

**Figure 3.15** On left, surface flooding in Guatemala City; on right, an underpass is closed in heavy rains (both in September 2010).

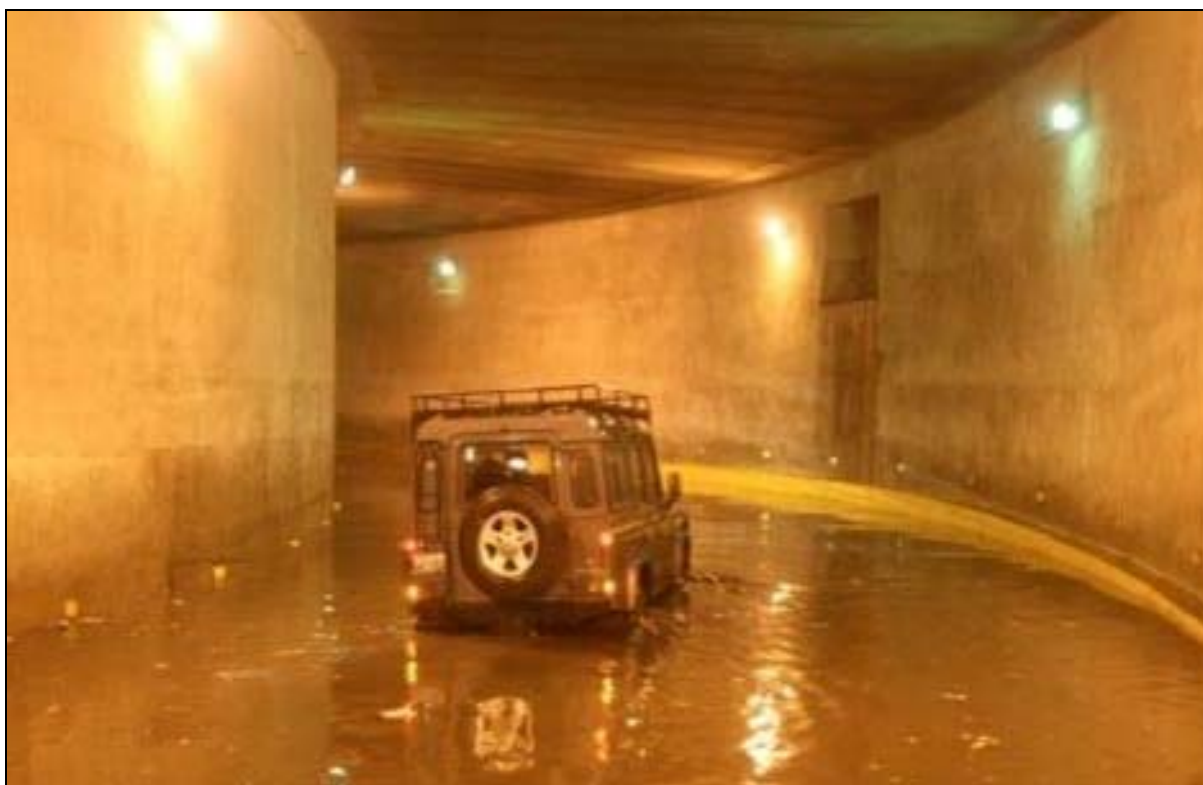
The Director of Works acknowledged that the blocked drains have caused continual flooding problems since the eruption. There have been incidences of flooding in areas that have not previously flooded, and existing flood-prone areas have become worse. During our field visit, heavy rains caused surface flooding, and caused an underpass to flood and become impassable (Figure 3.16). The municipality would like to be able to clean out the drains but currently lack the funds.

**Figure 3.16** Flooded underpass, Guatemala City, early June 2010 (photo: Director of Works, Guatemala City municipality).

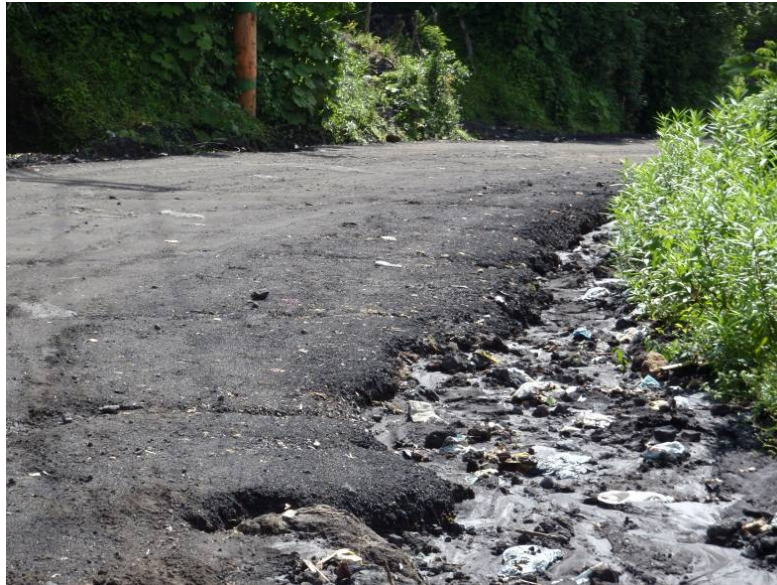
The road linking the small settlements of El Cedro and San Francisco de Sales (Figure 1.3) received approximately 20 cm of tephra fall, ranging in size from sand-sized up to approximately 3 cm diameter. According to a local guide in San Francisco de Sales, there was no vehicle access to the town on the day after the eruption as the road was too slippery. The road was not cleared, but eventually the surface compacted down and a new road surface was formed on top of the tephra layer (Figure 3.17).

**Figure 3.17** Road to San Francisco de Sales, showing compacted tephra road surface.

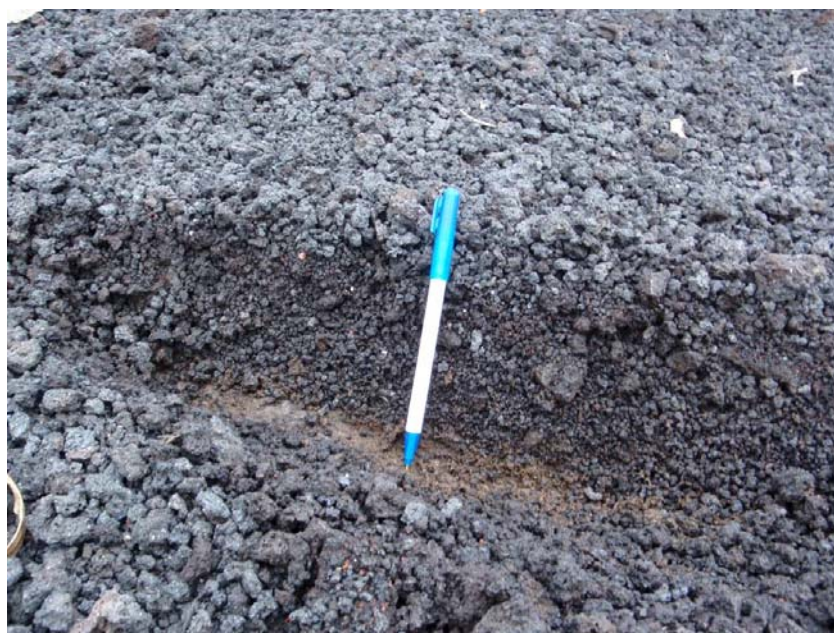
Up to 20 cm of coarse-grained lapilli fell on San Francisco de Sales and Calderas. After compaction, tephra deposits were approximately 10-12 cm thick at the time of our visit (Figure 4.1).

**Figure 4.1** Ground cover of coarse lapilli (tephra layer is ~10 cm thick), San Francisco de Sales, 19/9/2011).

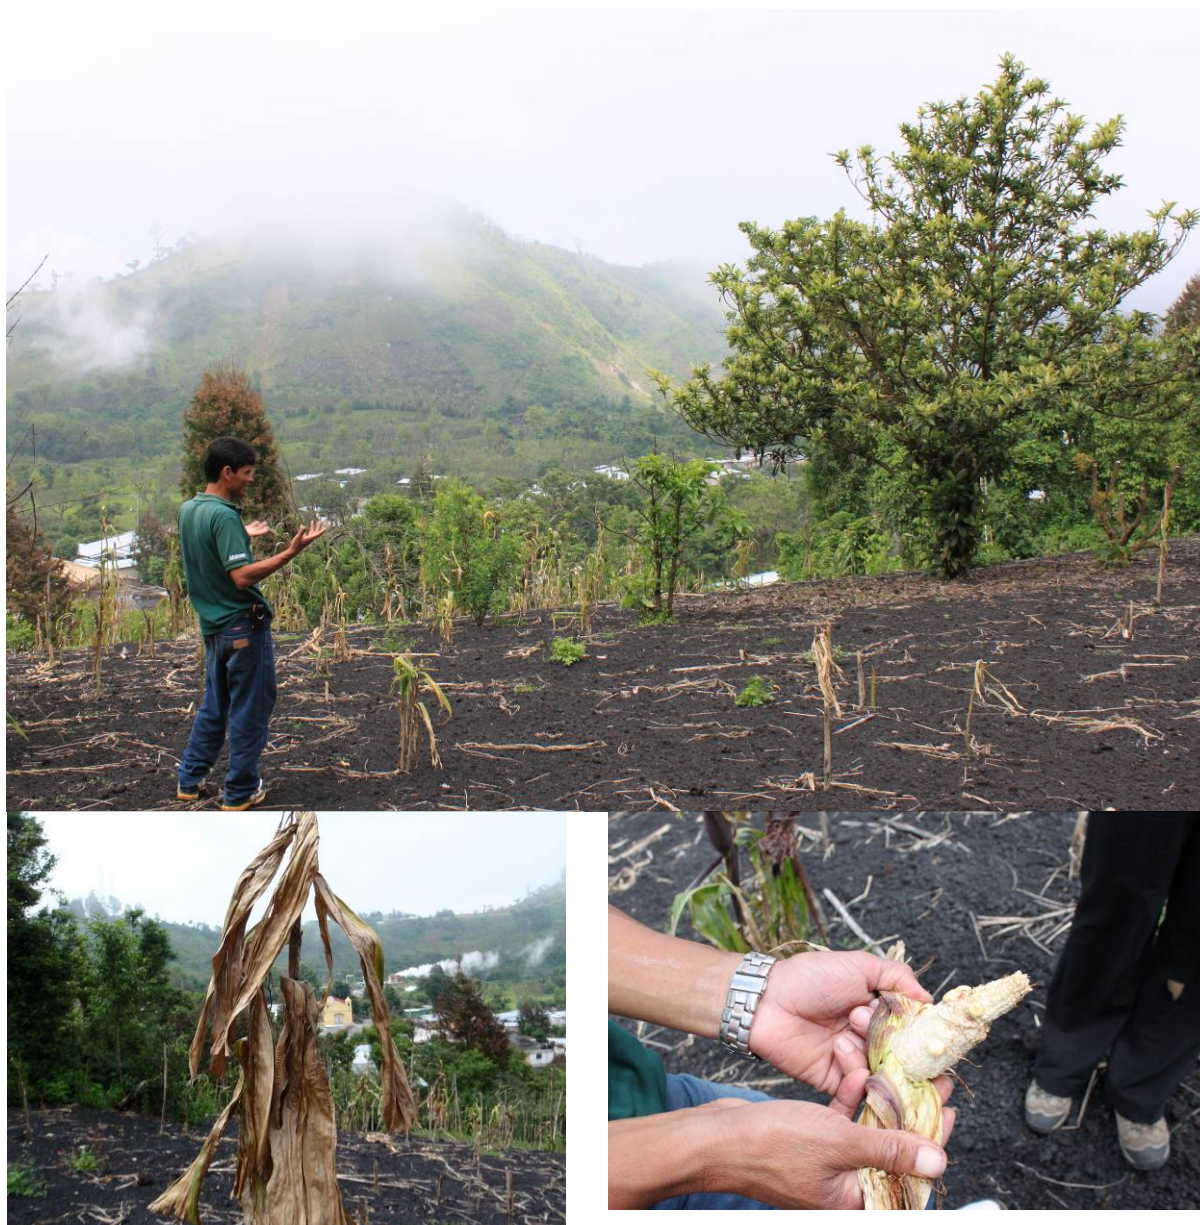
The lapilli fall caused extensive damage to crops in this region (Figure 4.2). The area also received larger ballistic clasts (lower right of Figure 4.2), some of them incandescent. The local farmer reported that crops suffered both crush damage and burn damage. There may also have been acid damage but no further information was available on this topic. No crops could be harvested after the 27 May eruption.

**Figure 4.2** Farmer surveys his damaged maize crops, San Francisco de Sales (19/9/2011).

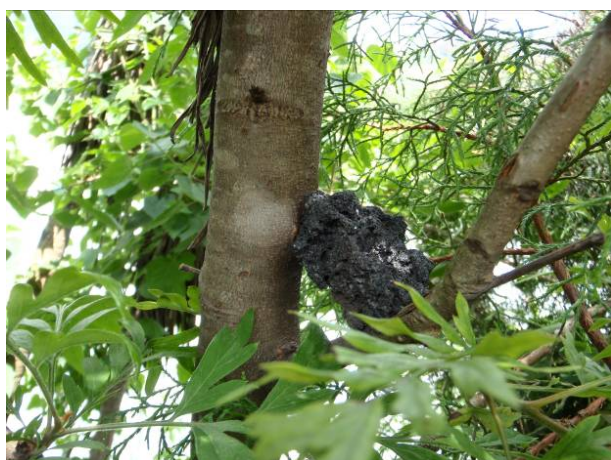
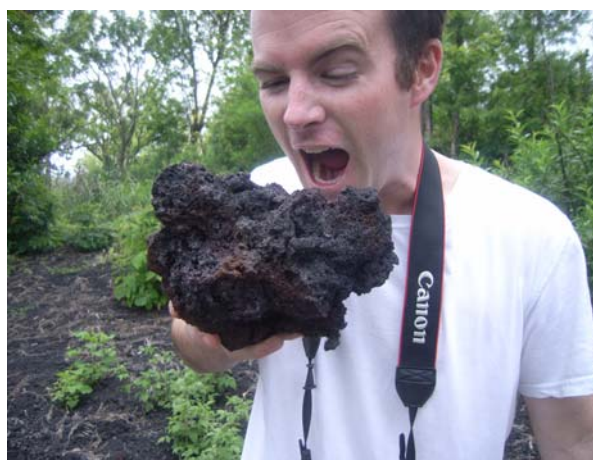
At the time of our visit, on 19 September 2010, large ballistic clasts of up to approximately 20 cm long axis were still visible (Figure 4.5). While roof repair was underway, several severely damaged roofs remained (Figure 4.6).

**Figure 4.5** Ballistic clasts in vicinity of San Francisco de Sales, 19 September 2010. (approximately 20 cm long axis).
